Docket No. SA-537

NATIONAL TRANSPORTATION SAFETY BOARD

Attachment 1 – Photographs

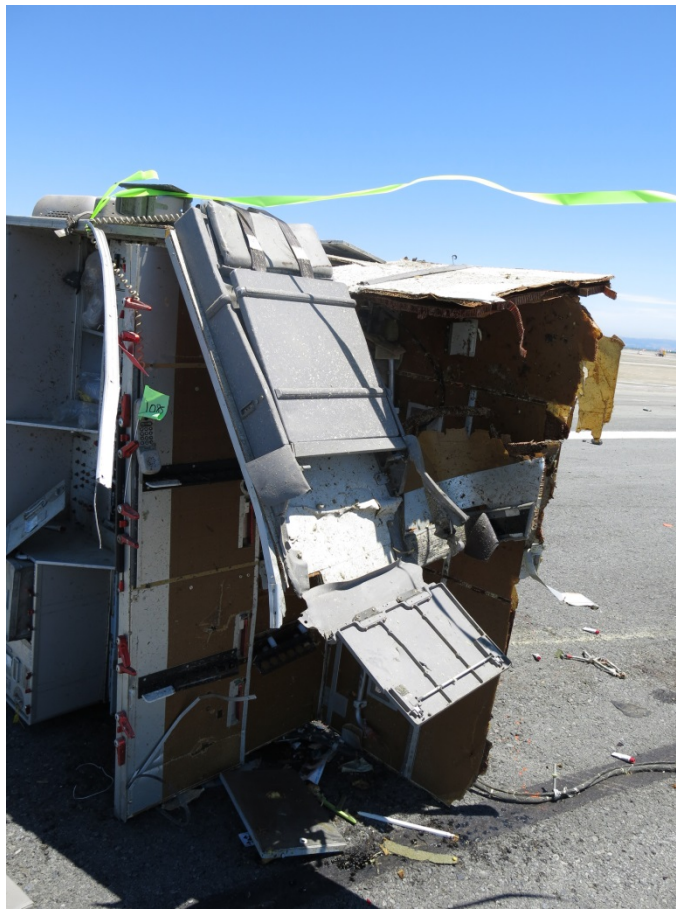
Photo 58. Aft-facing F/A jumpseat R3.

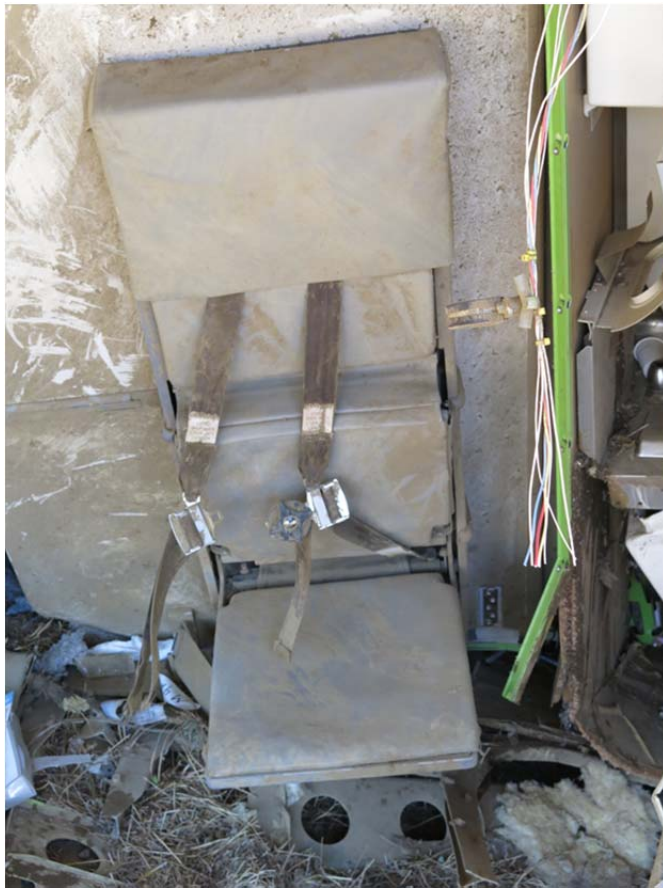
Photo 60. Forward-facing F/A jumpseat R4.

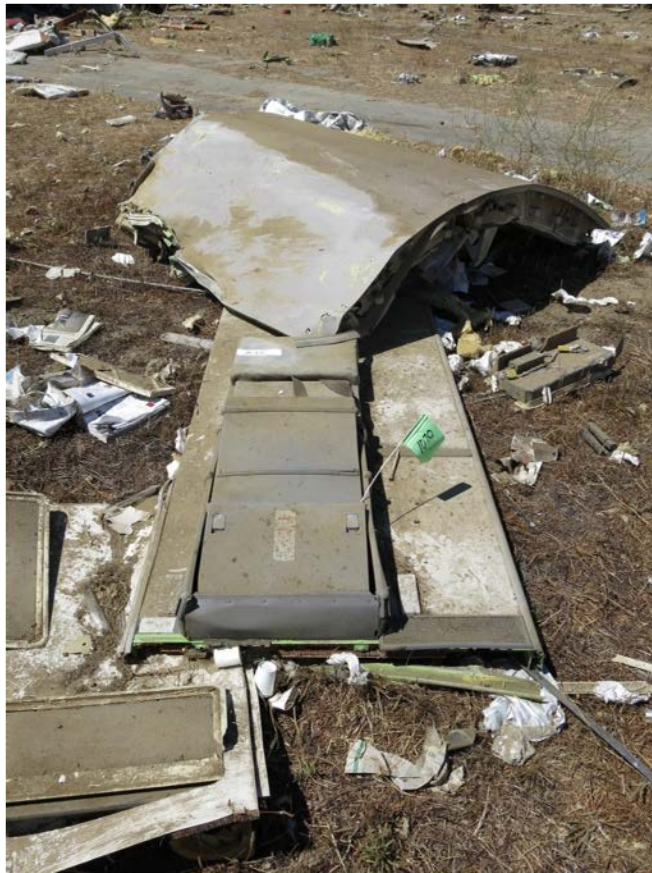
Photo 61. Aft-facing F/A jumpseat M4A.

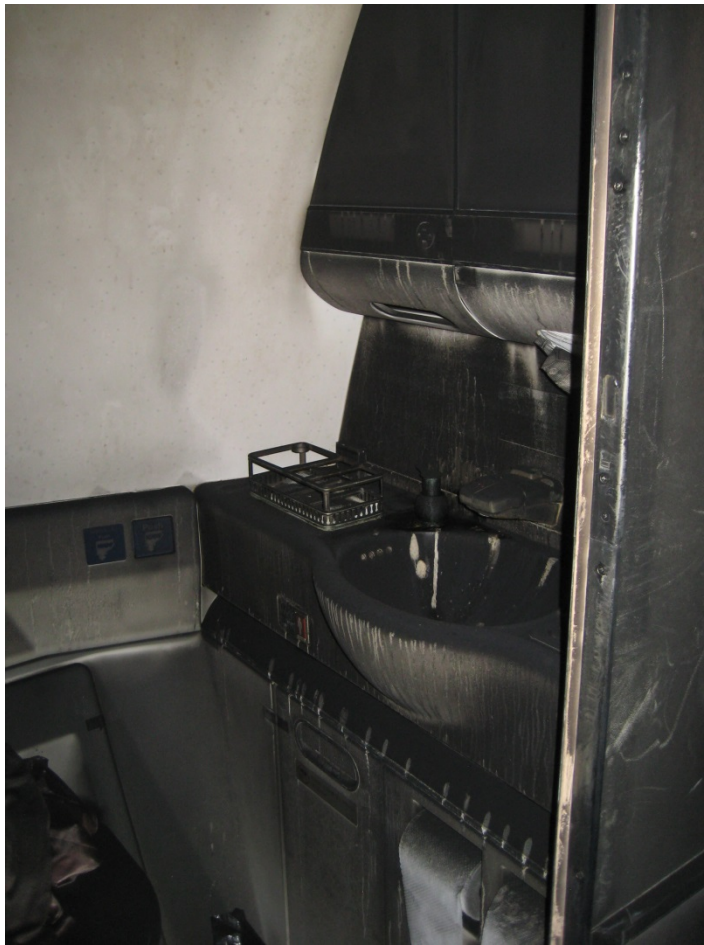
Photo 62 Aft-facing F/A jumpseat M4B.

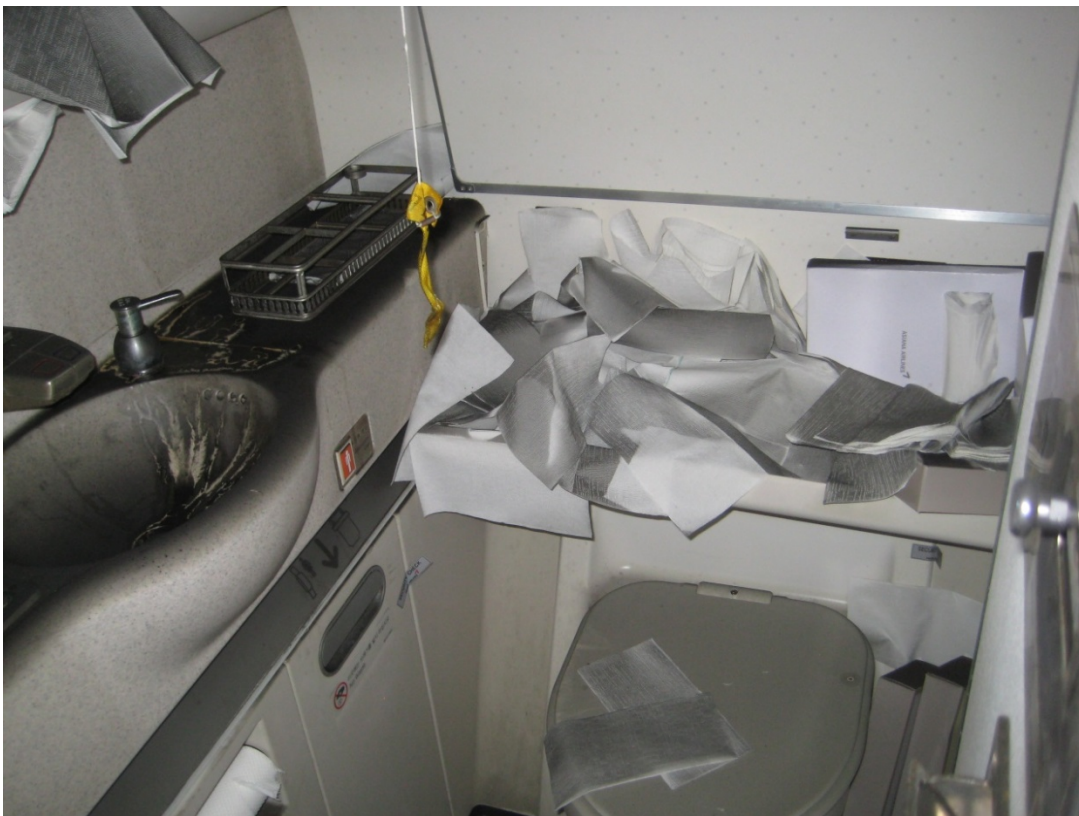
Photo 63. Door 1L forward lavatory (closest to the cockpit).

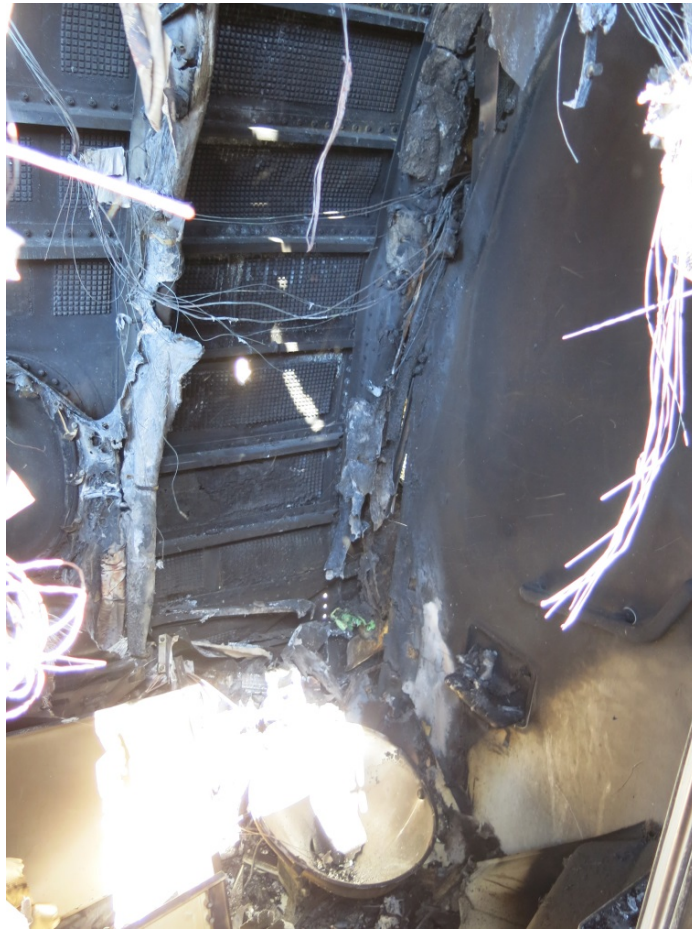
Photo 64. Door 1L forward lavatory (adjacent to door 1L).

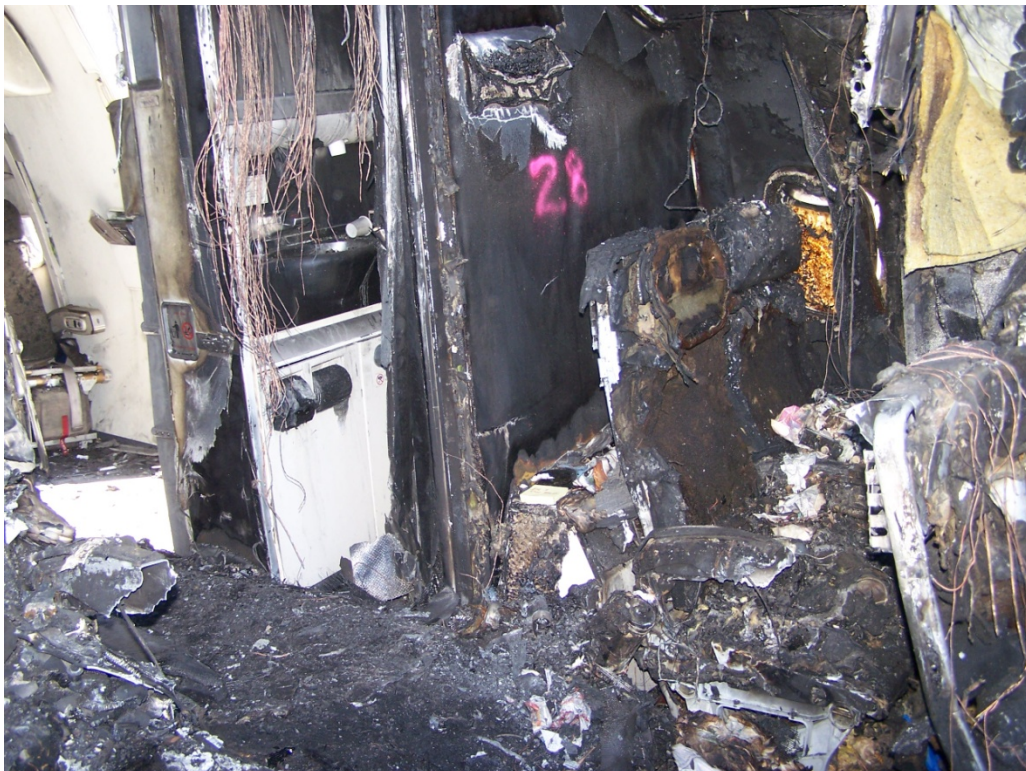
Photo 65. Lavatory aft of door 2R

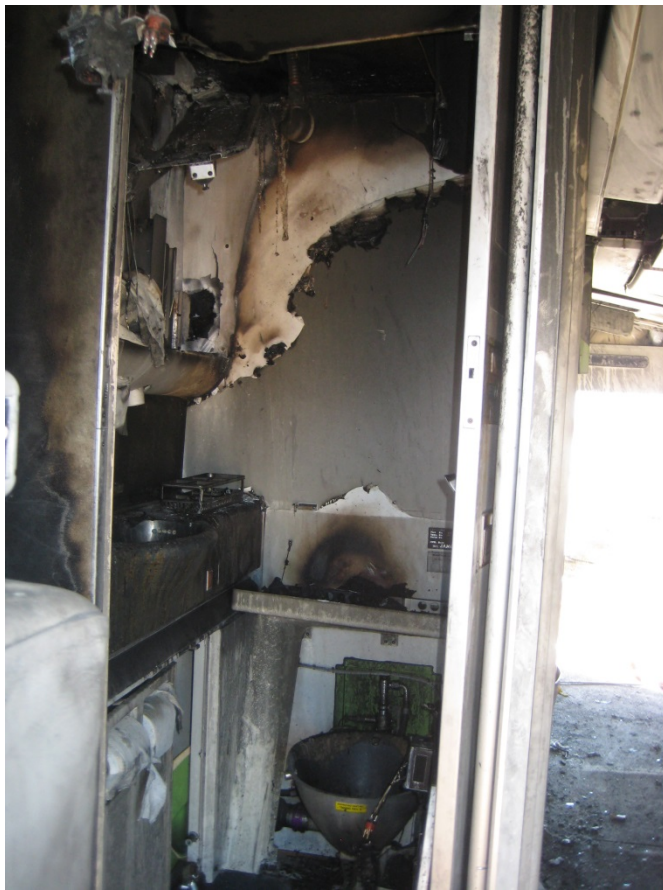
Photo 66. Left lavatory near door 3L, behind row 28 AB.

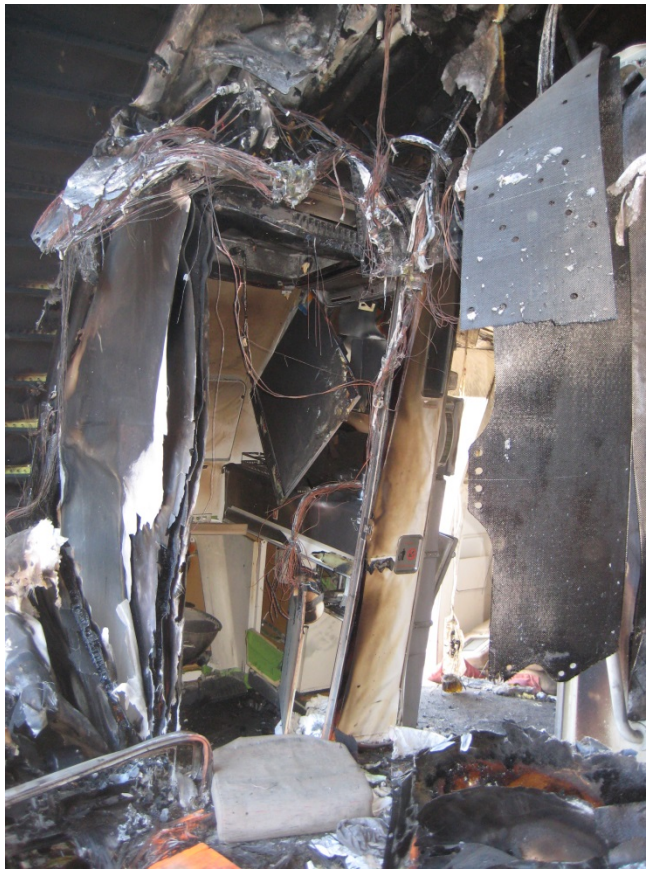
Photo 67. Center lavatory near door 3L.

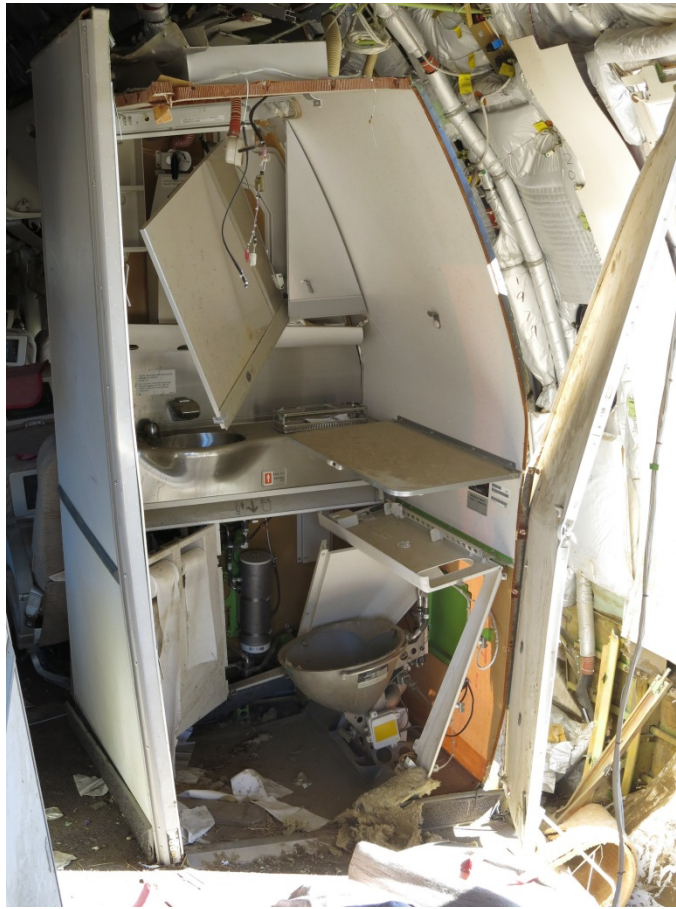
Photo 68. Lavatory forward of door 3R.

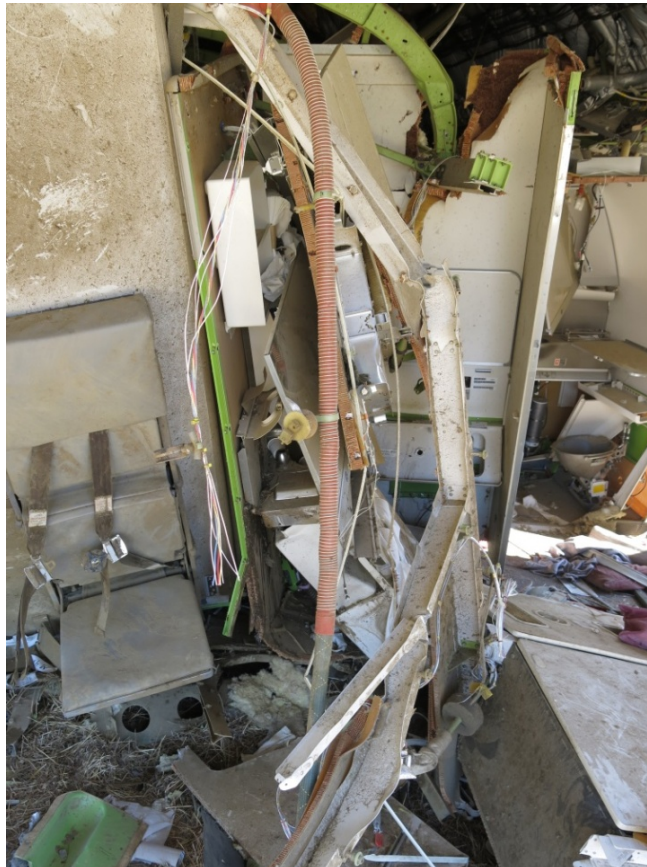
Photo 69. Lavatory forward of door 4R.

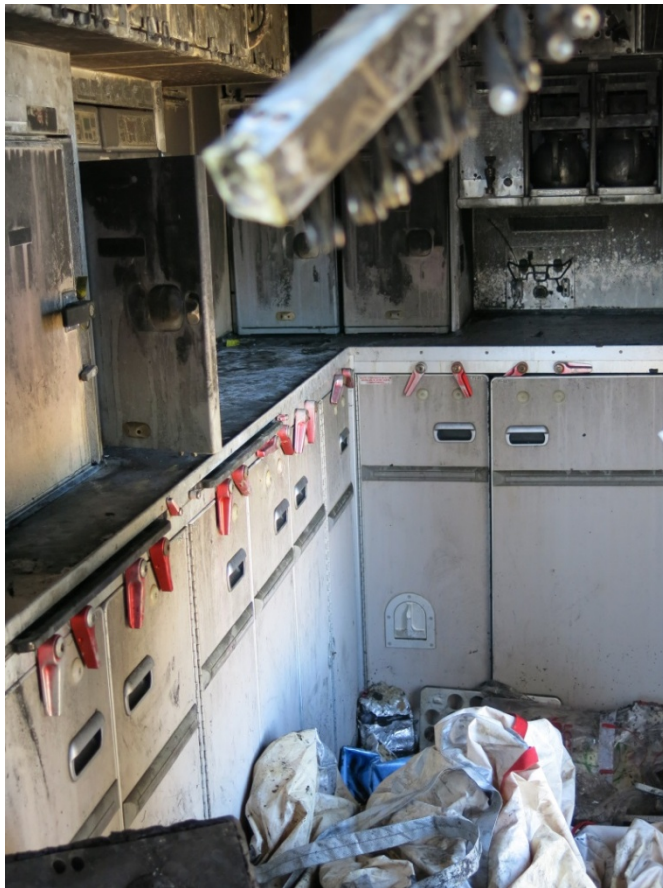
Photo 70. Right center lavatory near door 4R.

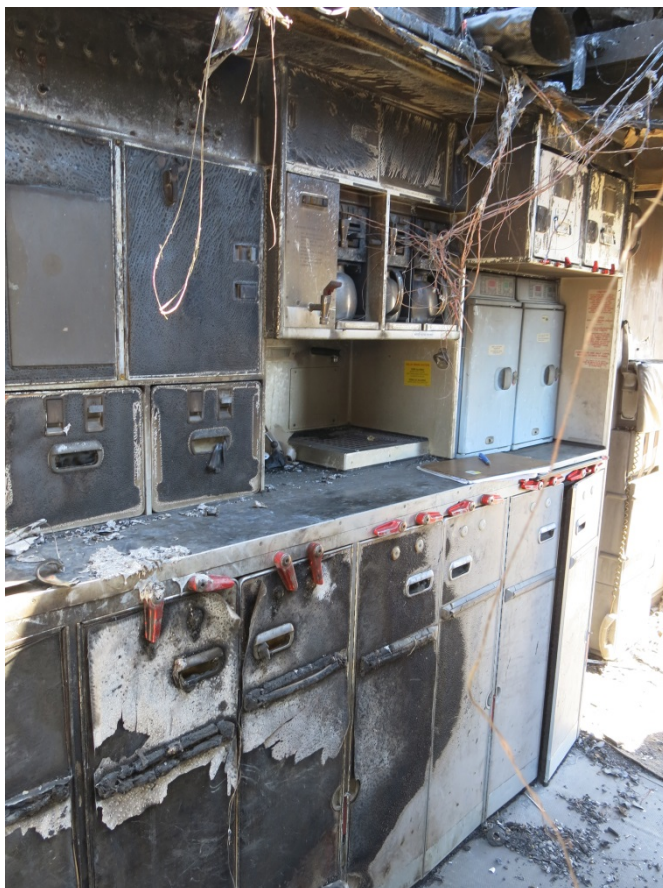
Photo 71. Forward galley at door 1R.

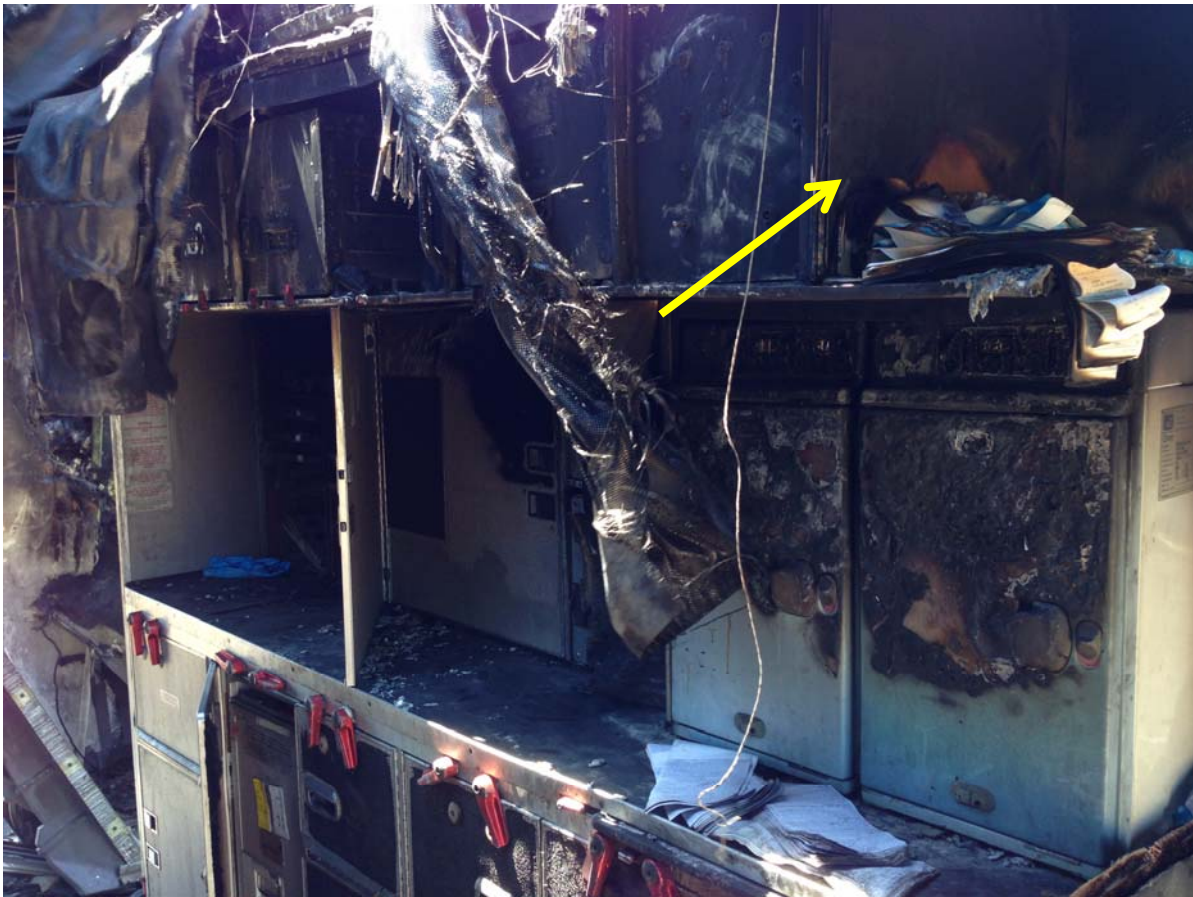
Photo 72. Aft mid-cabin galley.

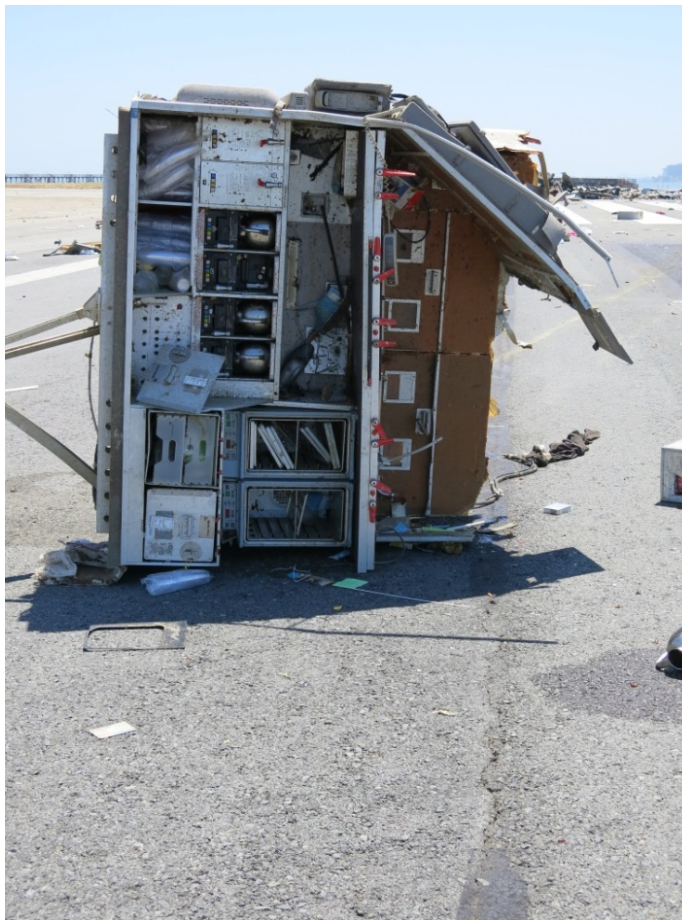
Photo 74. Location of missing galley bin in forward mid-cabin galley.

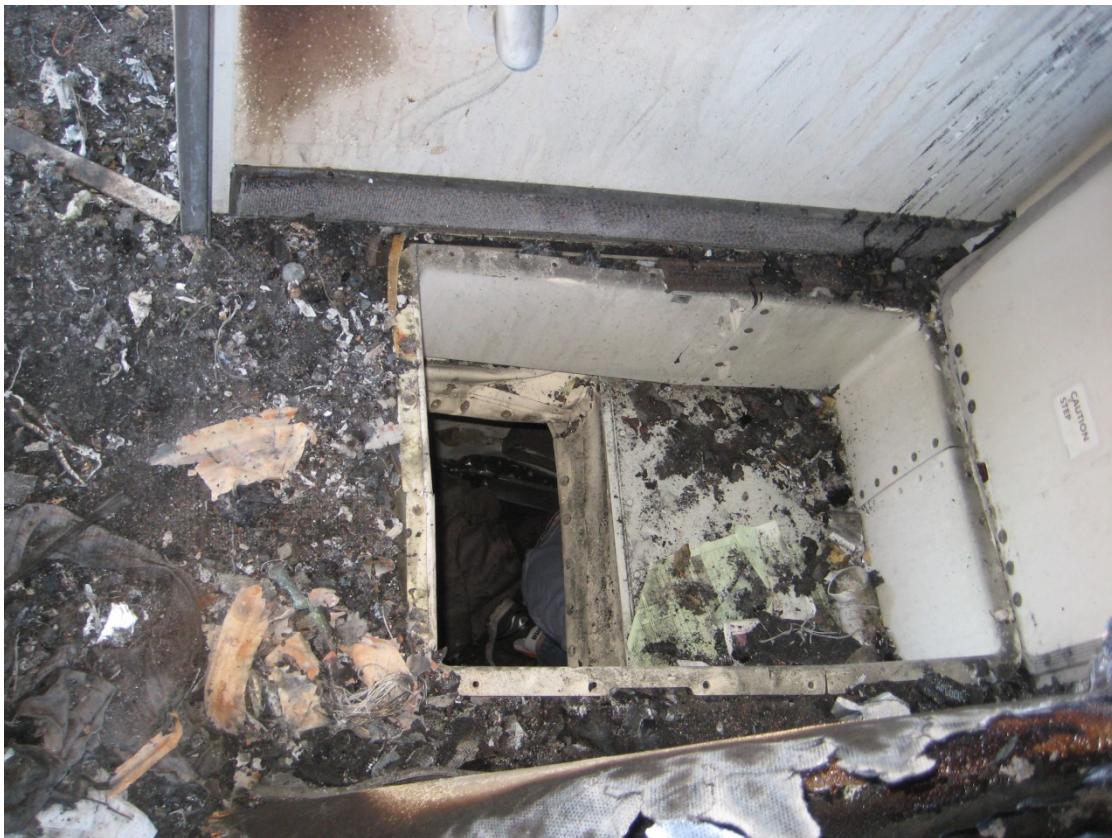
Photo 75. Aft galley.

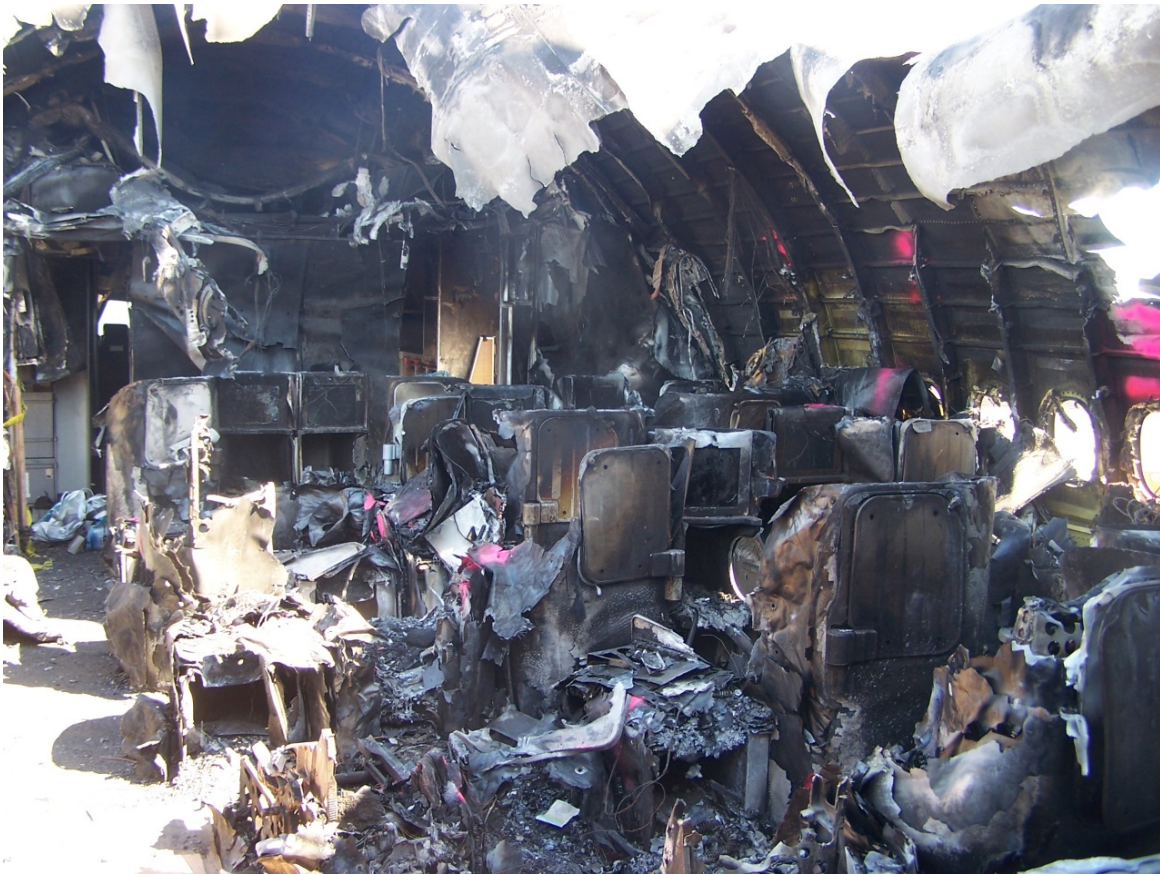
Photo 76. Hatch door entry to crew rest.

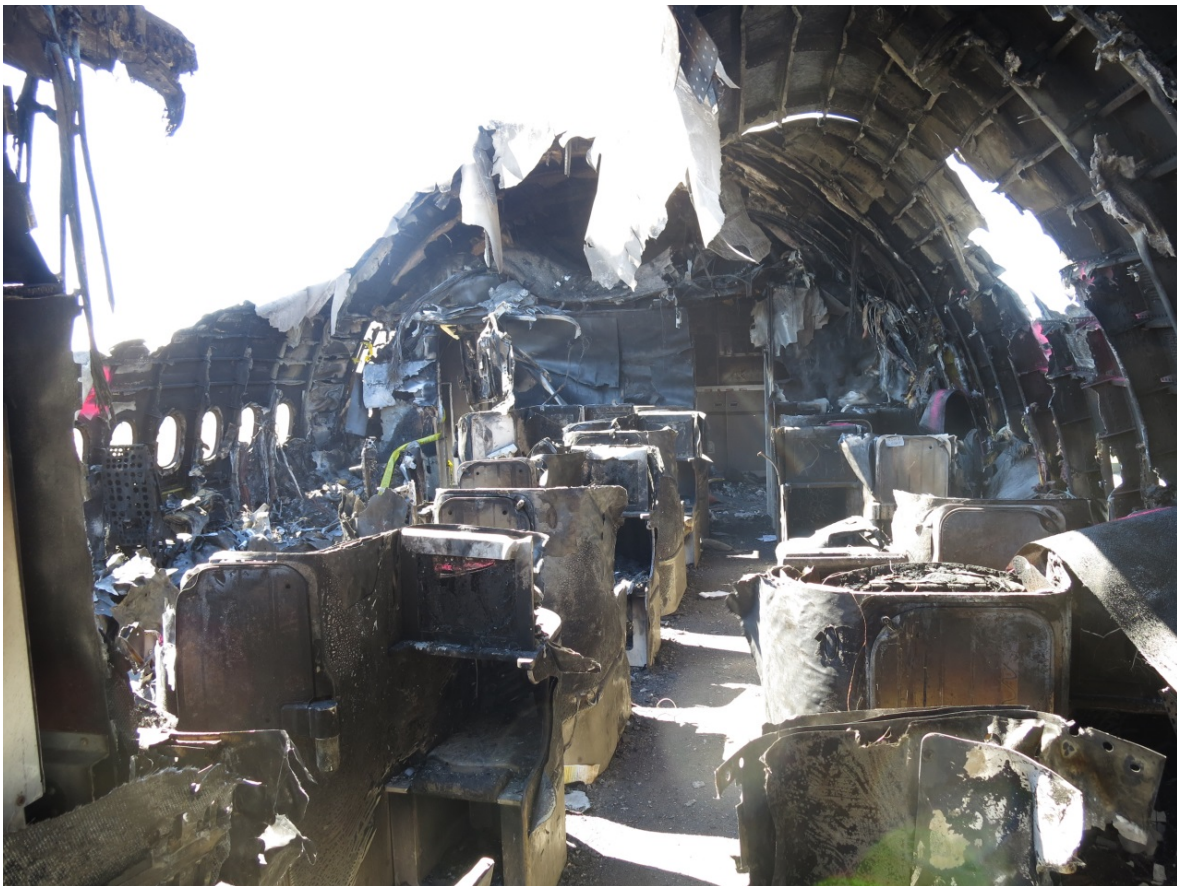
Photo 79. Forward-facing view of A-zone from left aisle near row 5.

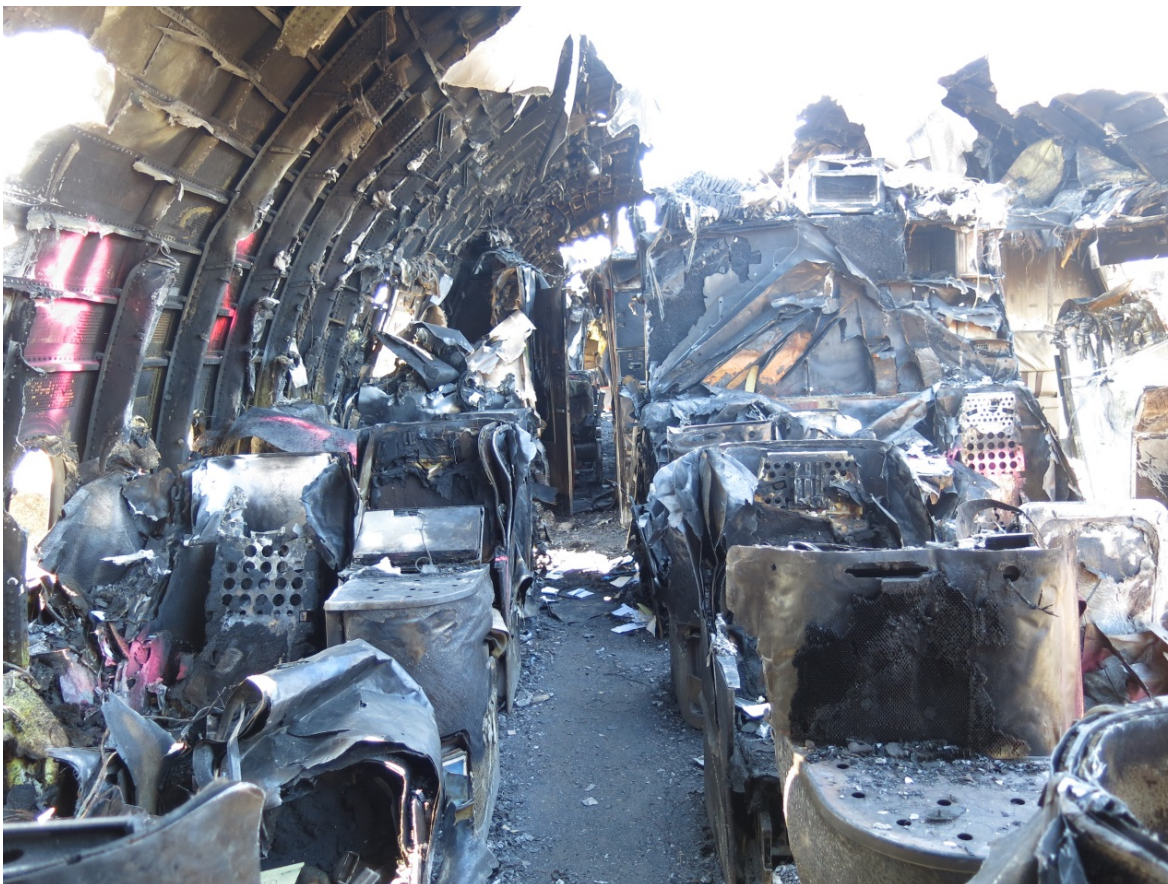
Photo 80. Forward-facing view of A-zone from right aisle near row 6.

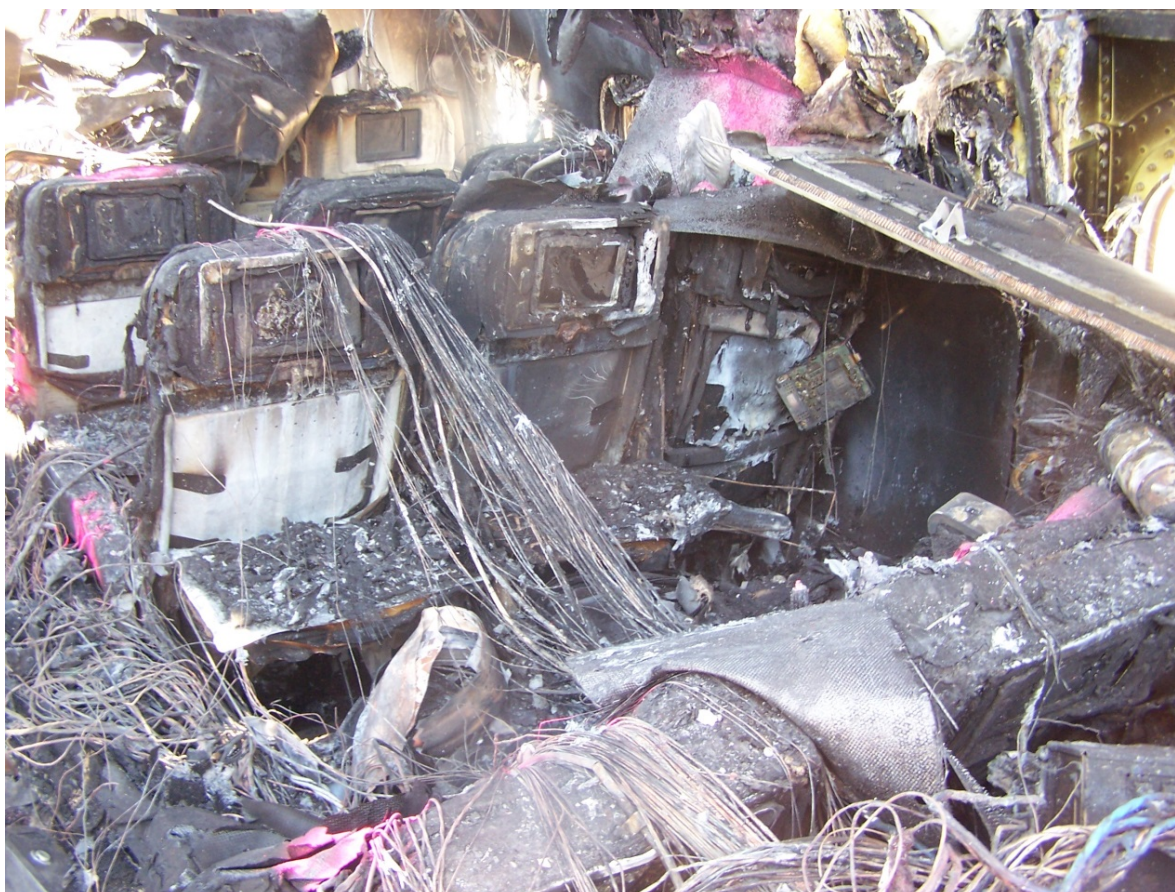
Photo 81. Aft-facing view of A-zone from right aisle near row 3.

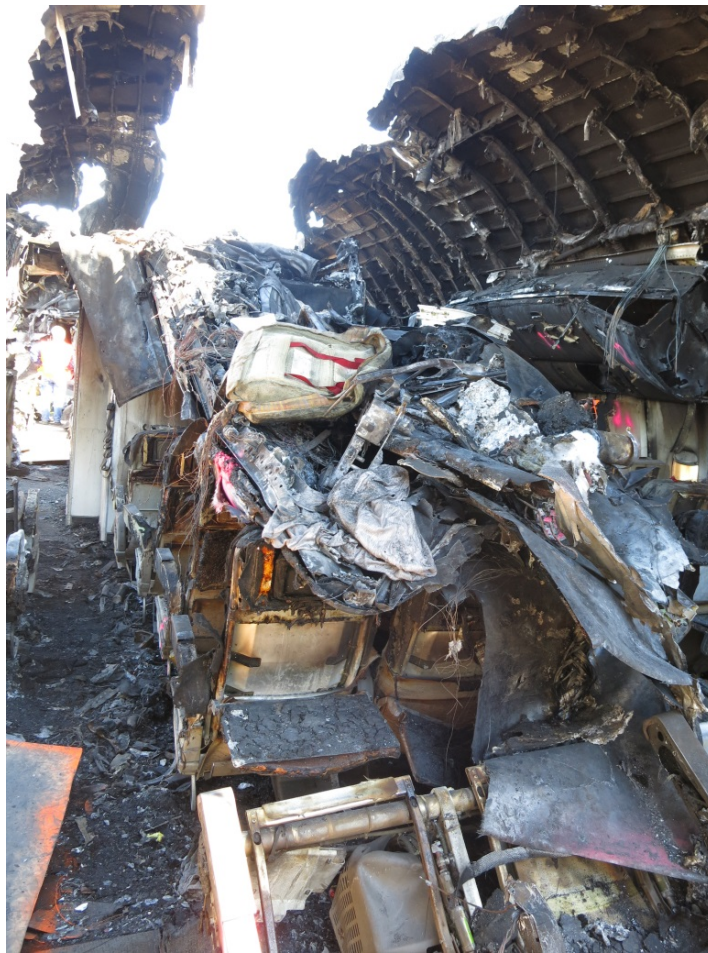
Photo 82. Forward-facing view of B-zone right-side seats (prior to debris removal).

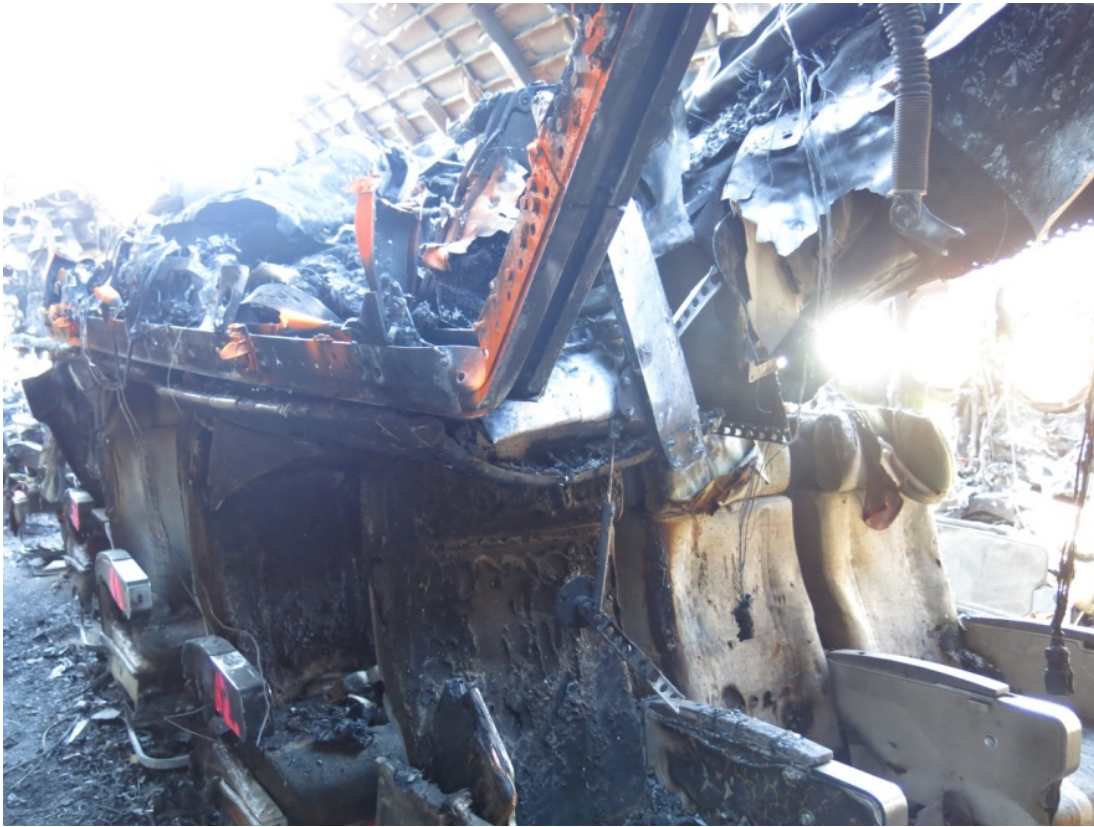
Photo 84. Aft-facing view of B-zone seats from left aisle near row 11 after debris removal.

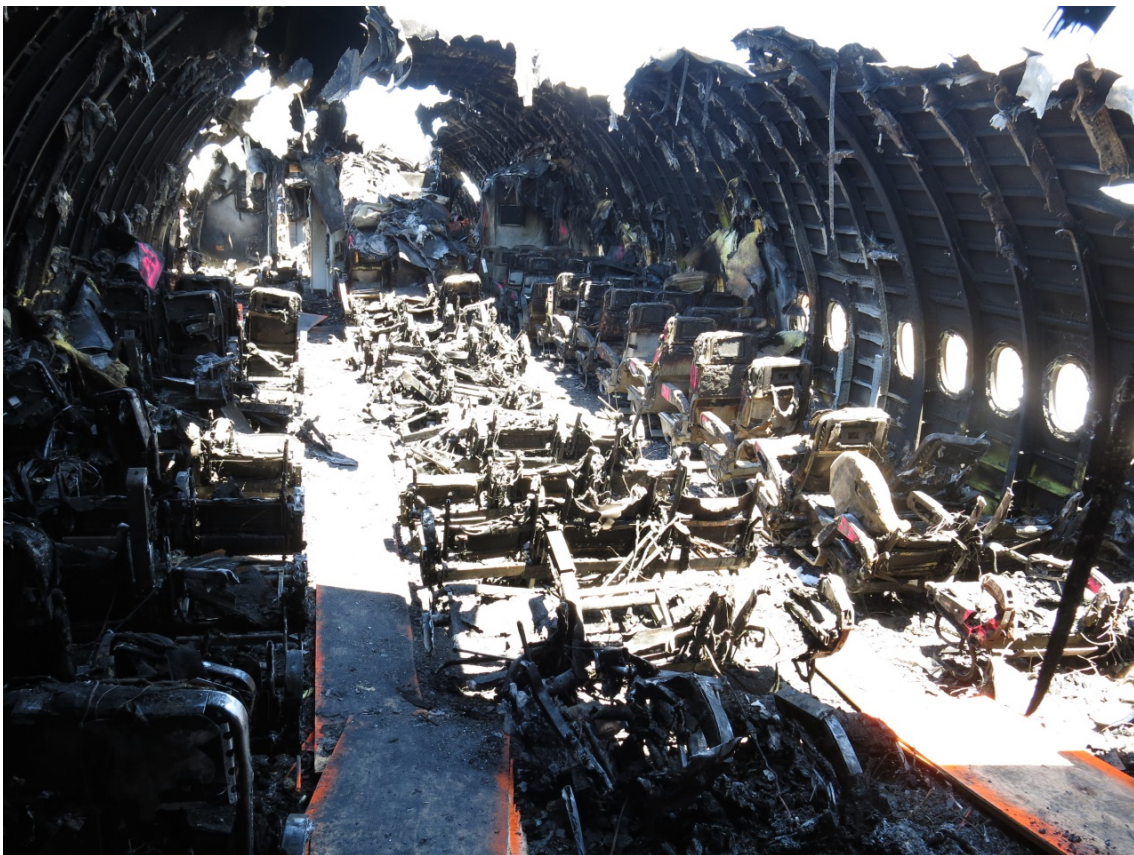
Photo 85. Aft-facing view of B-zone center seats from right aisle near row 10.

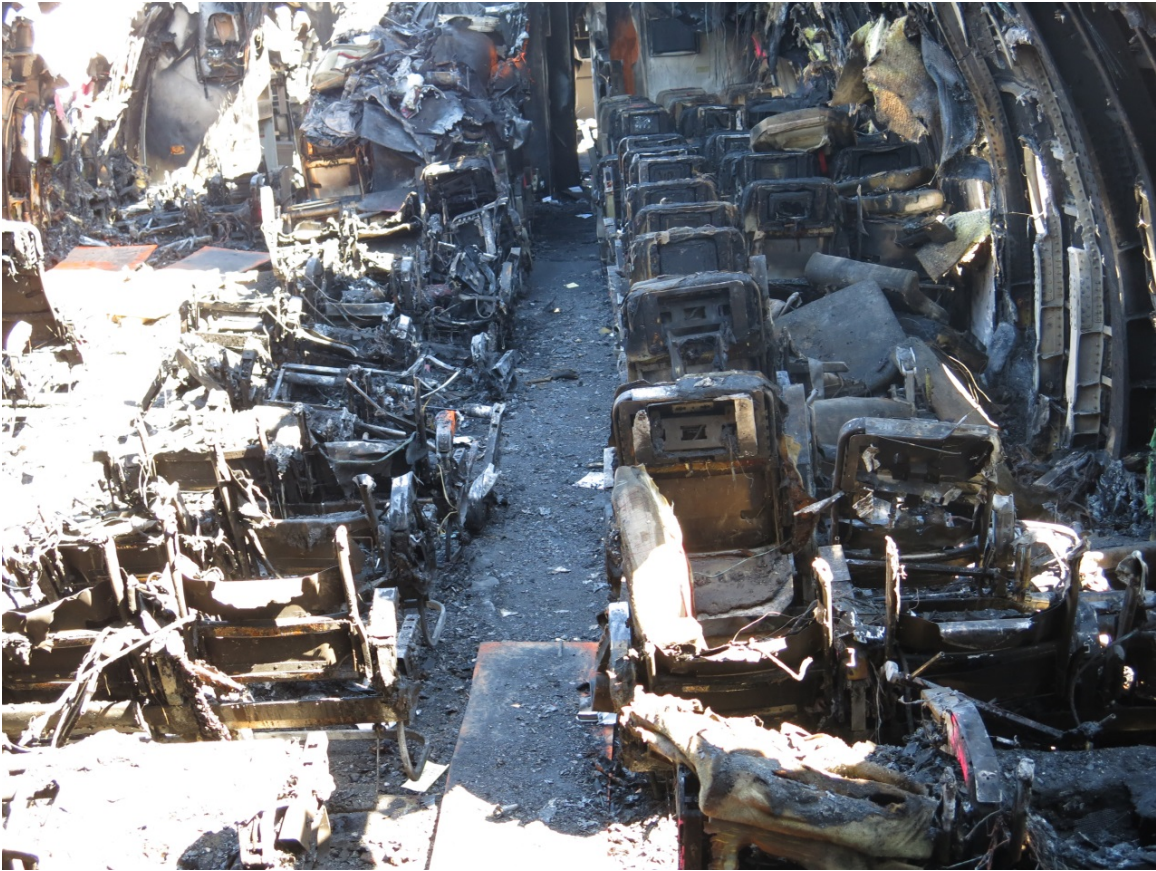
Photo 86. Forward-facing view of B-zone from left aisle near row 28 after debris removal.

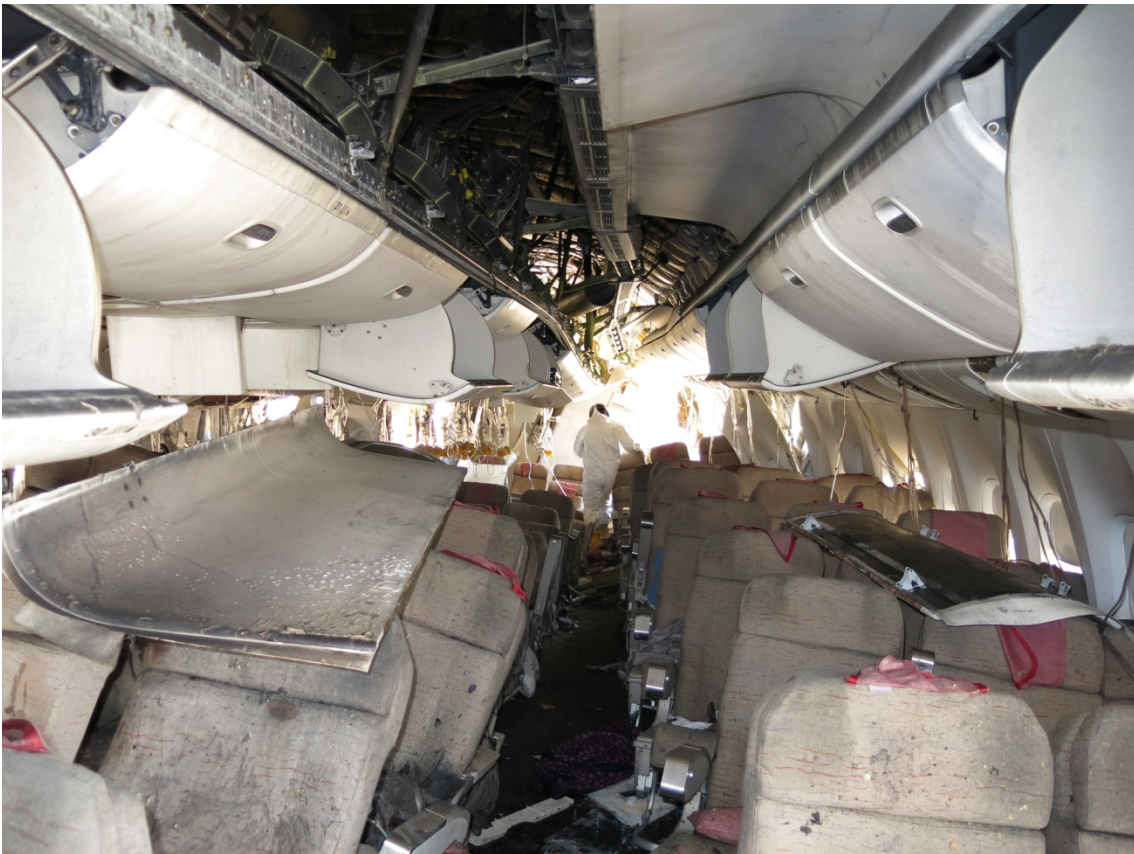
Photo 87. Forward-facing view of B-Zone from right aisle after debris removal.

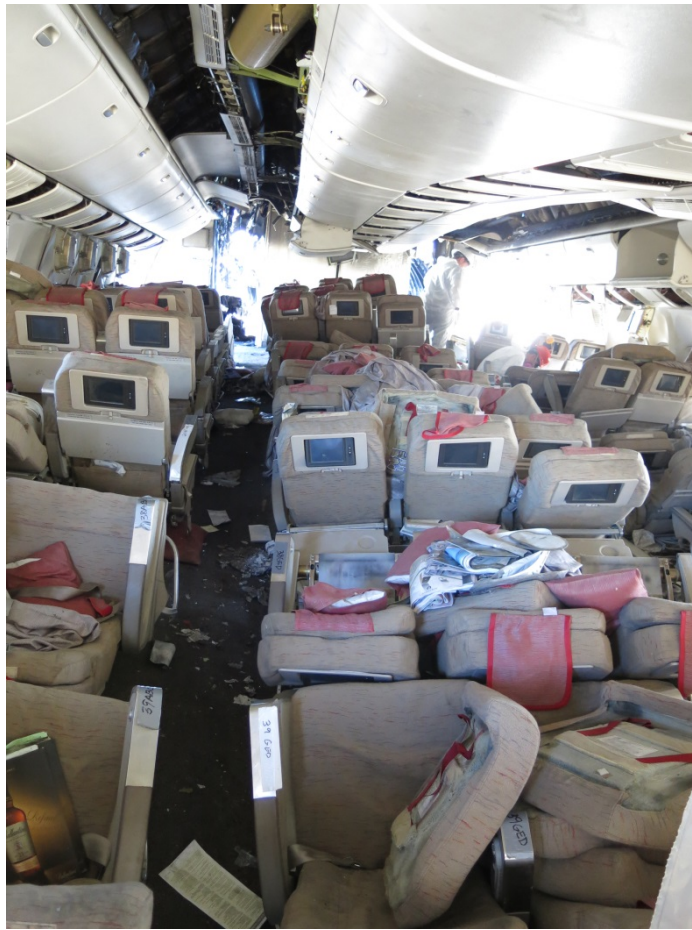
Photo 88. Aft-facing view of C-zone from left aisle near row 29.

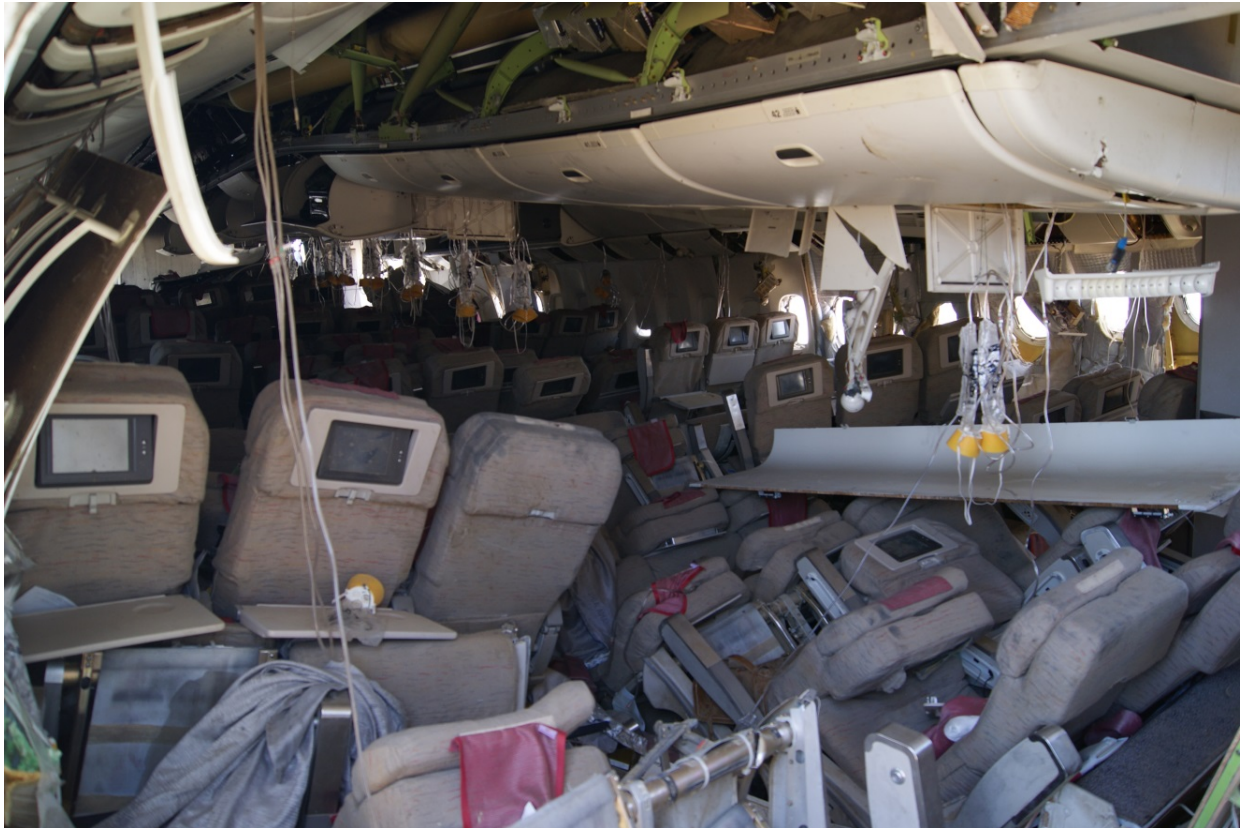
Photo 89. Forward-facing view of C-zone from left aisle near row 39.

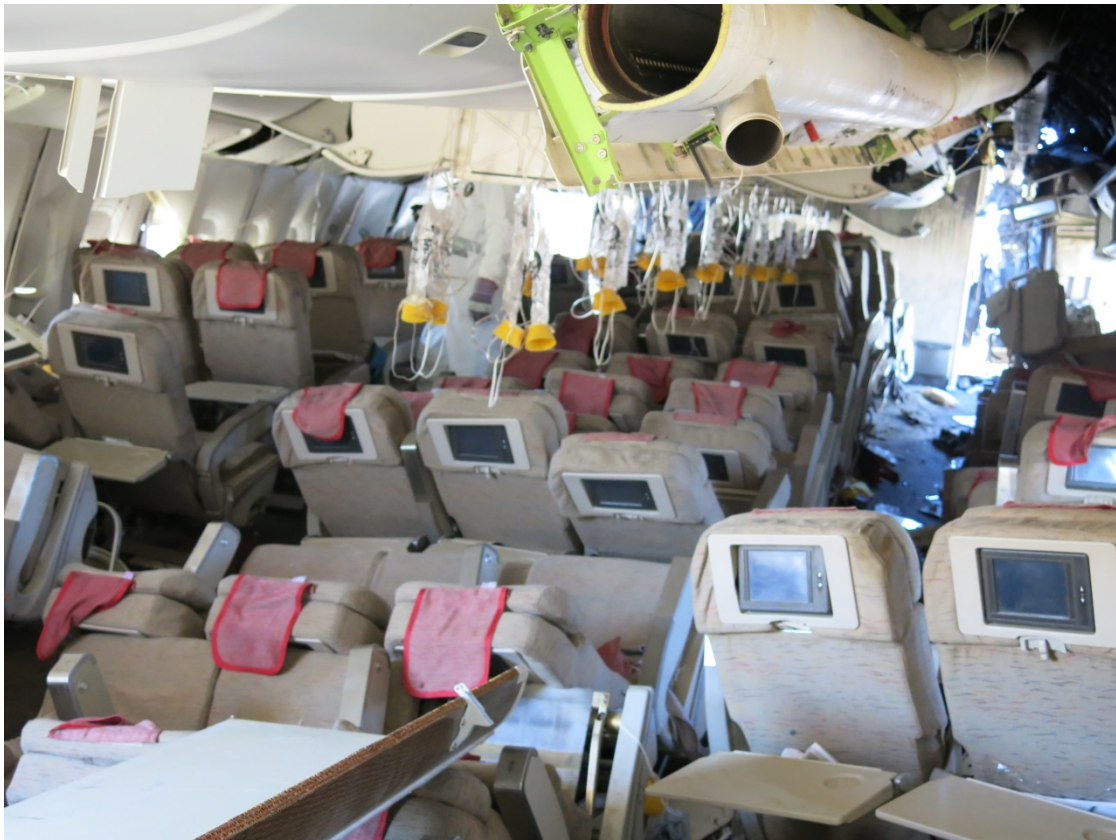
Photo 90. Forward-facing view of C-zone from door 4L.
